MAMMOTH, W. VA.  
SE 1/4 CLENDENIN 15' QUADRANGLE  
N 36 15 - W 81 15 / 7.5  
1957

## LANDSLIDES AND RELATED FEATURES OF THE MAMMOTH, W. VA. QUADRANGLE

by  
GREGORY C. OHLMACHER

OPEN FILE MAP 83-80 (C-6)

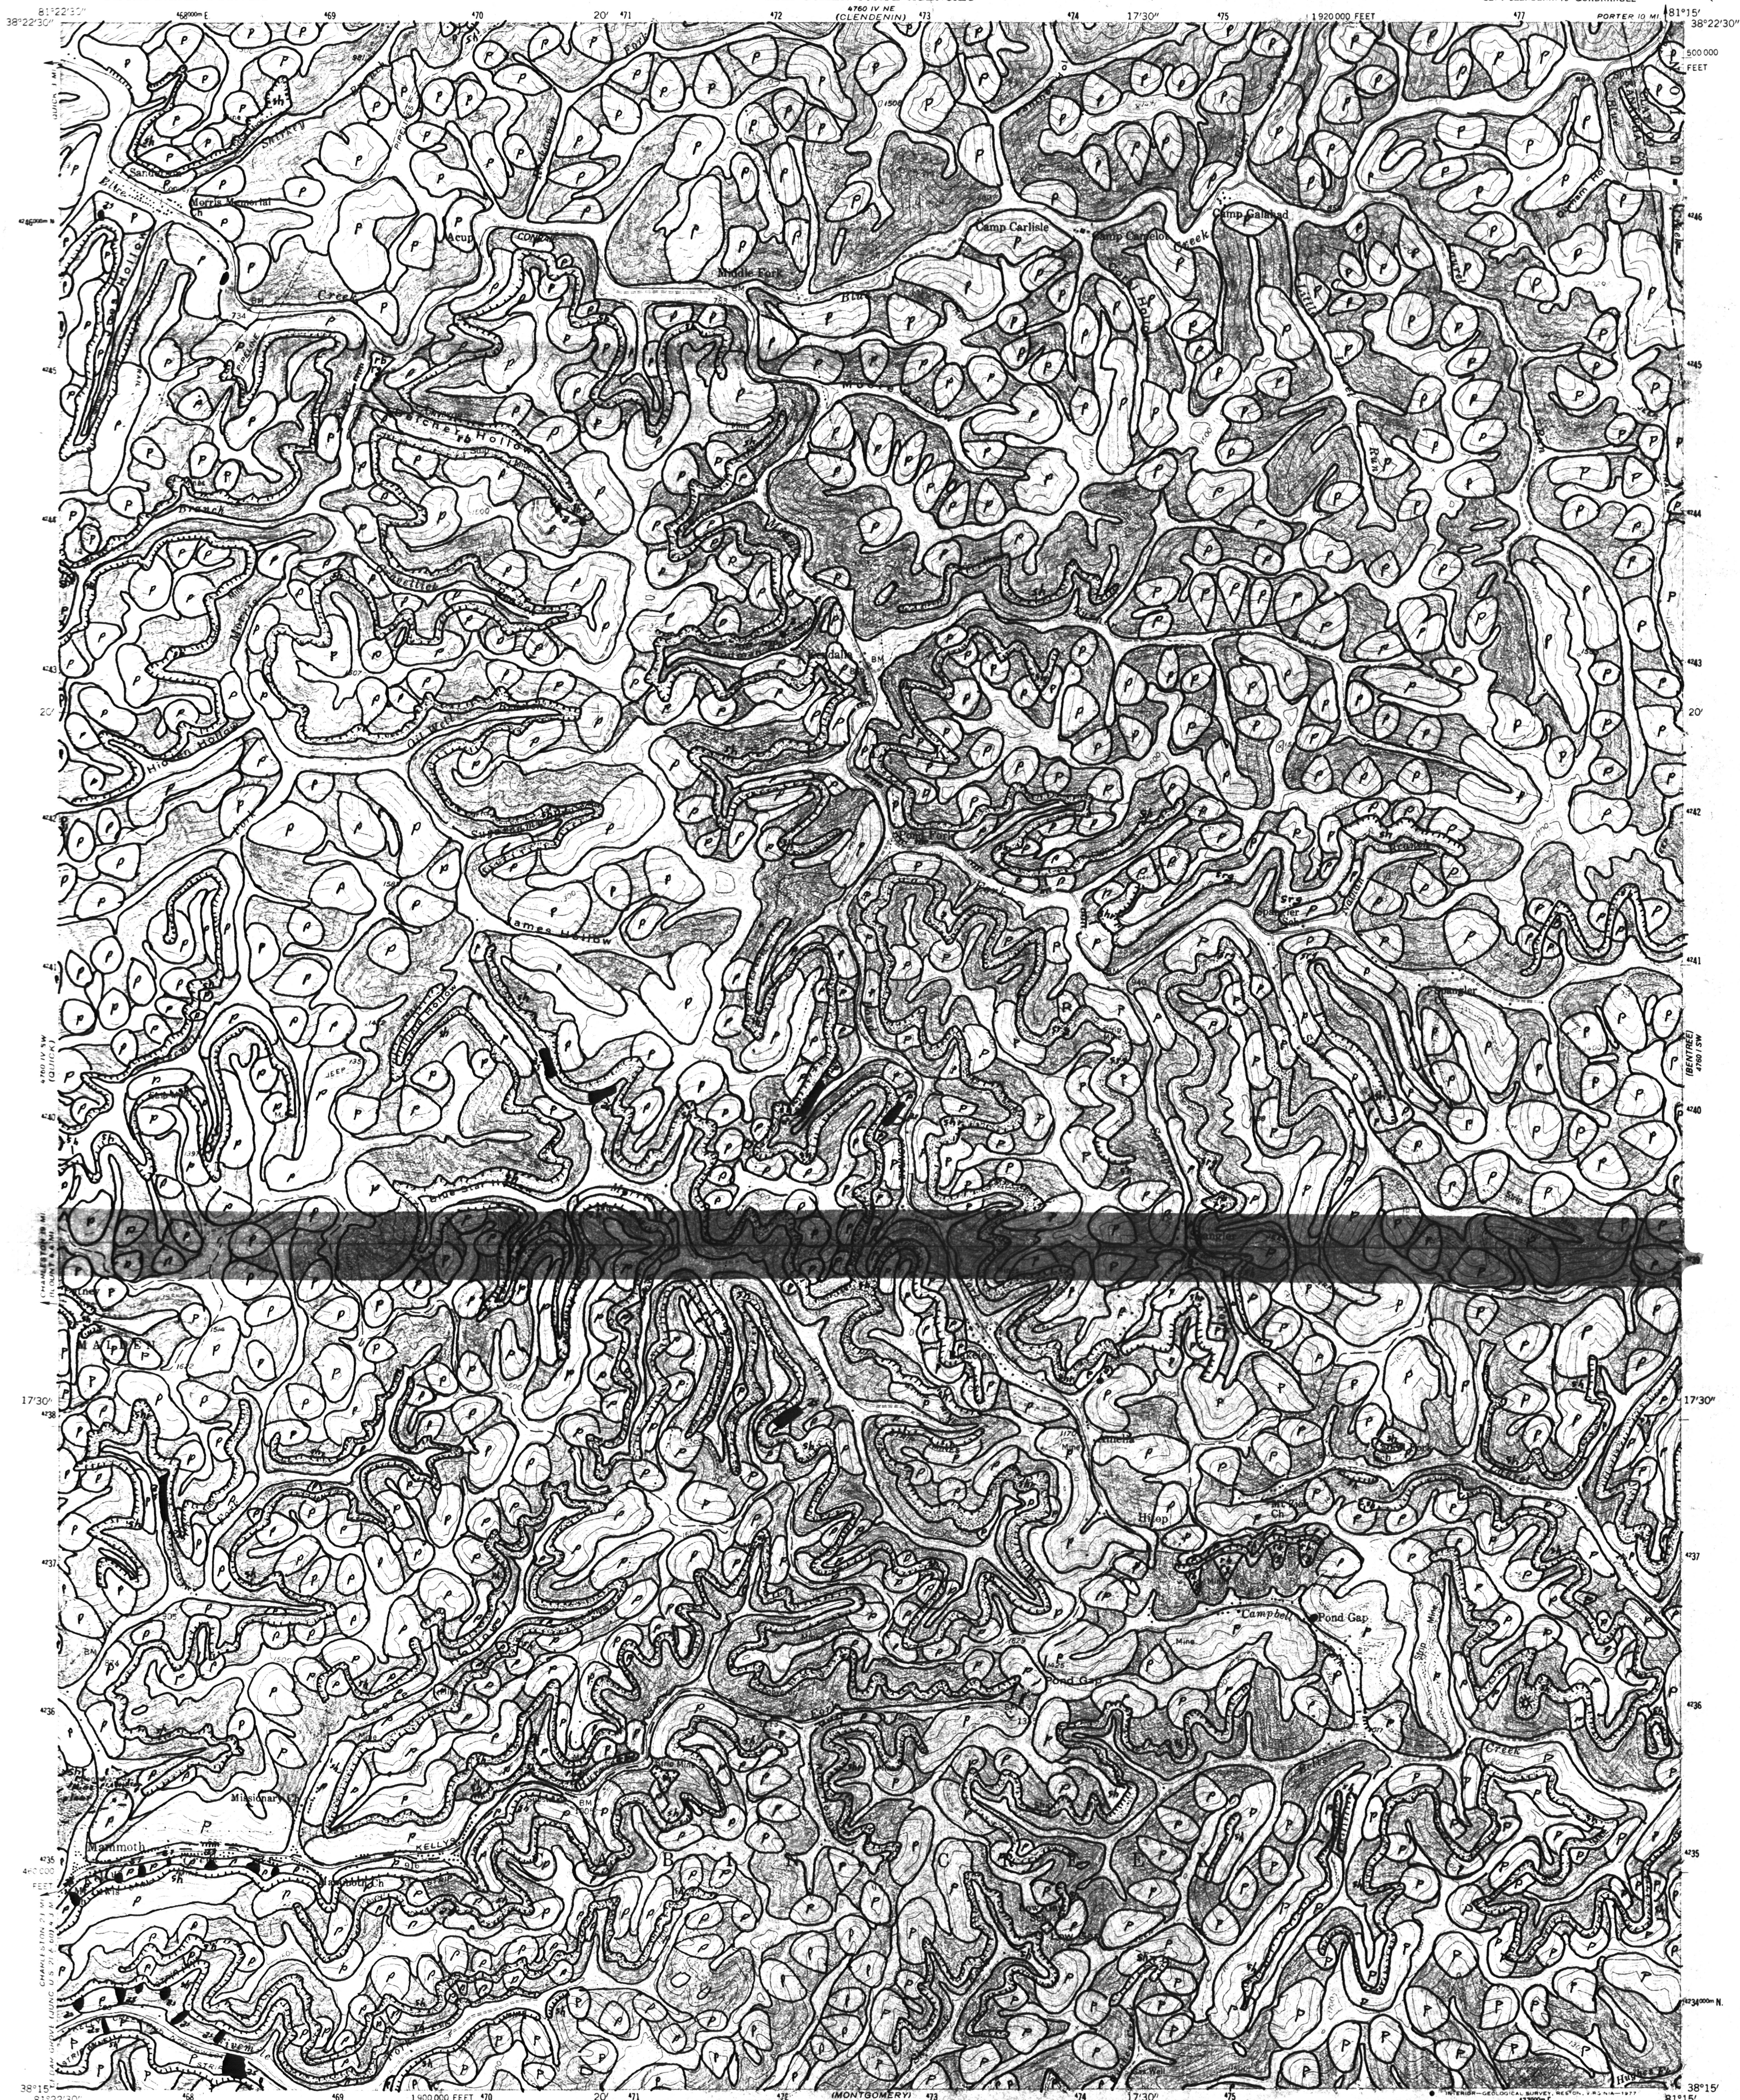
**ACTIVE OR RECENTLY ACTIVE LANDSLIDE**  
Complex landslide composed of earthflow, debris slide, earth and rock slump. Identified from historical records, and from scars, debris and other field evidence. Ground extremely unstable, sliding accelerated by excavation, loading and changes in drainage conditions. May include areas with several active slides too small to be shown separately.

**OLD LANDSLIDE**  
Area of extensive hummocky ground caused by earthflow and earth and rock slump. Lacks clear evidence of active sliding. Relatively stable in natural, undisturbed state, generally not affected by small structures properly sited in areas away from the toe of the toe, can be reactivated by extensive, rapid excavation, loading, and changes in ground water and surface water conditions. Area of old landslide probably includes recent ones not identified from field evidence or otherwise documented. Upslope boundary of landslide generally defined by modified scarp, but downslope (toe) may be gradual and not well defined.

**COLLUVIAL SLOPE**  
Valley wall along major streams with slope as steep as 40° (85%), stony, clayey silt soil up to 50 ft. (15 m) thick. Commonly buttressed by a terrace or bench at the toe of the slope, very susceptible to sliding by cutting of toe area, removal of terrace or bench, and overloading; slide commonly activated without apparent cause.

**AREAS SUSCEPTIBLE TO DEBRIS FLOWS AND DEBRIS AVALANCHES**  
Primarily shallow, narrow ravines and chutes with accumulation of stony colluvium generally 10 ft. (3 m) or less in thickness; susceptible to rapid movement during intense rainfall. Most ravines and chutes designated show evidence of former debris flows and avalanches. Symbol-a designates historical debris flow or debris avalanche.

**AREAS SUSCEPTIBLE TO ROCKFALL**  
Steep, locally vertical, natural and man-made slopes and cliffs, 15 ft. (4.5 m) or more high, formed dominantly of sandstone, limestone, sandy shale, mudstone and claystone. Interbedded mudstone, claystone and shale weather rapidly leaving sandstone and limestone rock faces unsupported.

**SOIL AND ROCK SUSCEPTIBLE TO LANDSLIDING**  
Soil and rock similar to that involved in landslides elsewhere in map area; primarily areas underlain by claystone, mudstone and shale associated with other rock types. Rock weathers rapidly on exposure forming clayey soil highly susceptible to sliding. Includes covos (U-shaped, shallow valleys) containing thick layers of clayey soil that are very susceptible to sliding where excavation breaks continuity of slope and where overloaded by artificial fill.

**AREAS LEAST PRONE TO LANDSLIDES**  
Map areas in which no patterns or symbols are shown; primarily valley floors, ridge tops and broad benches, modification by excavation and fill may lead to local landslides.
